Project Profile

Alumni Hall at Georgia State University

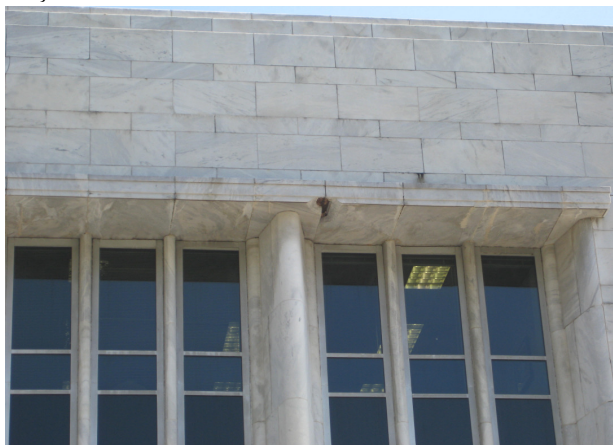
A TCE Services Structural Engineer visited Alumni Hall to observe the stone façade and to discuss areas of distress with GSU maintenance personnel. Severe spalling and cracking of the stone façade was observed at the eyebrow near the roof line over the main entrance of the building. TCE Services consulted with GSU via phone conversation to assist in forming an appropriate scope of engineering evaluation services.

Distress Stones at Eyebrow.

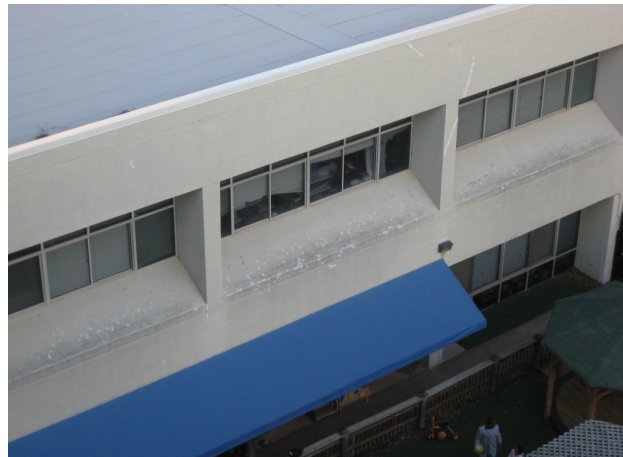
Distressed EIFS facade.

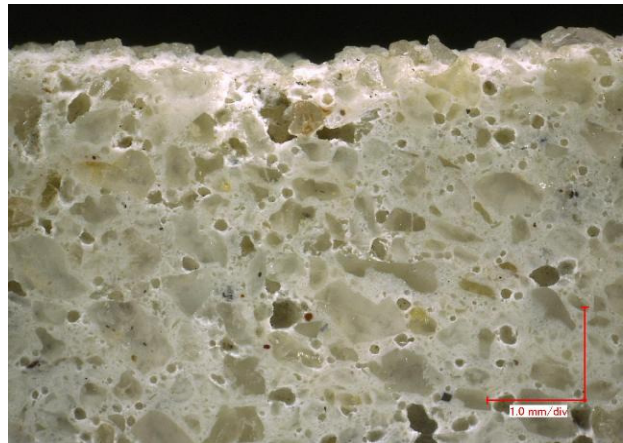
Mortar evaluation was performed at TCE Services' AASHTO accredited materials testing laboratory.

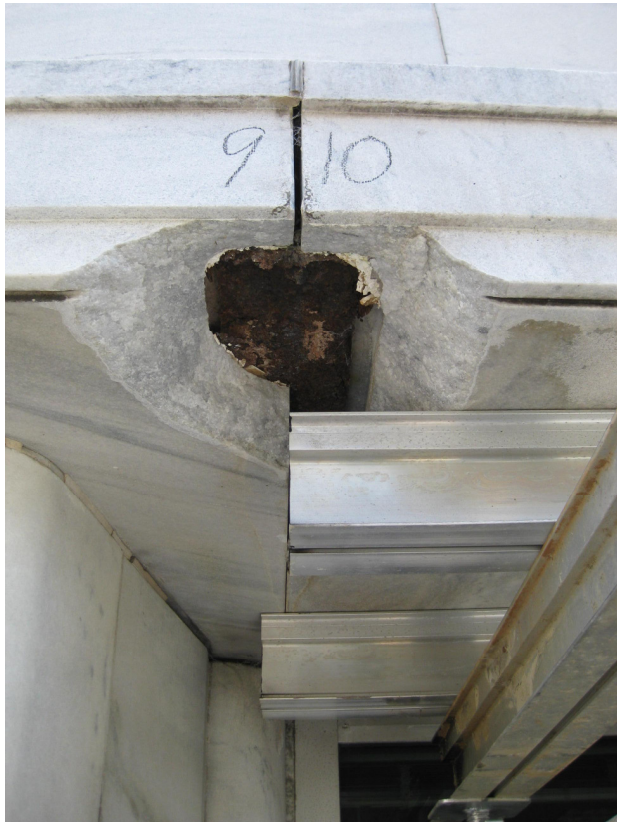
Failed Stone at eyebrow.

Close up inspections of the distressed eyebrow stone facade at the front entrance were performed. The stones that required removal and replacement or repair were identified on a plan or elevation view sketch. TCE Services consulted with specialty repair contractors to assist in the evaluation and development of conceptual repairs of the stone facade.
